**RAILWAY ACCIDENT INVESTIGATION  
REPORT**

**Occurrence of casualties among passengers of 7 up Tinsukia Mail train at Km./77/3-4  
between Pathsala and Tihu Stations on the Single Line New  
Bongaigaon Gauhati Metre Gauge Section of  
Alipurduar Division of Northeast  
Frontier Railway at  
13-09 hours**

**12 th March, 1981**

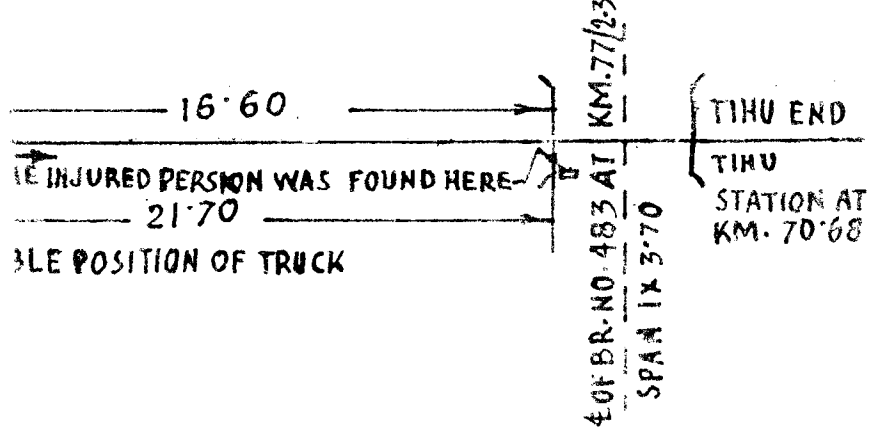
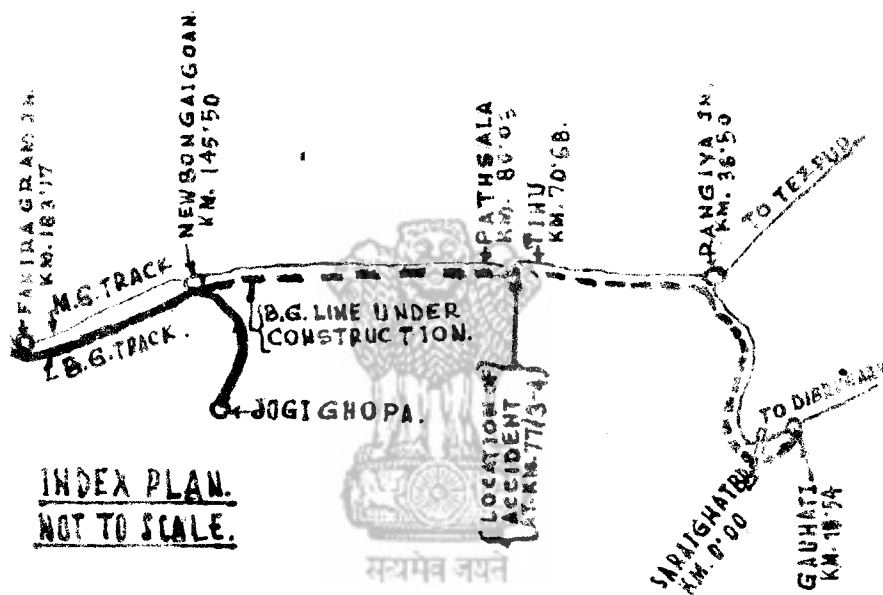
SECTION SHOWING PROBABLE POSITION OF COACH AT  
AT THE TIME OF ACCIDENT.  
SCALE - 2CM = 1M.

In this position it was observed that the truck would be fouling the moving dimensions of the metre gauge track.

fouling the metre gauge track. In the present case the truck was close enough to cause injuries to passengers who had kept their limbs projecting outside the window but it was far enough not to come in contact with the body of the coach.
